ABNORMAL STATE OF THE NORTHERN SEGMENT OF THE VISTULA SPIT

Anna Dobrovolskaya, Atlantic Branch of the P.P. Shirshov Institute of Oceanology (ABIORAS), Russia

Evgenii Burnashov, State Organization of the Kaliningrad region "Baltberegozaschita", Russia

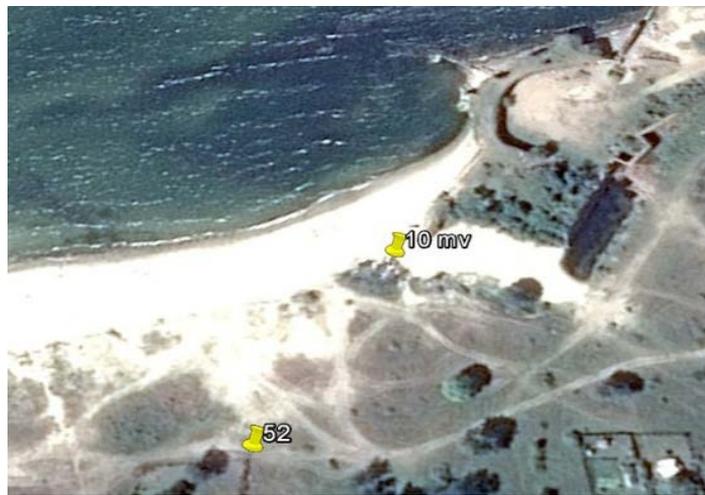
Fig. 2 – Location of monitoring points (10 mv – primary monitoring point, 52 - new point)

Shore dynamics in the village of Kosa has been annually specified, from 2003 to 2016 [5, 6]. From 2003 to 2007, the observations were carried out by IO RAS. In 2007, the monitoring point had to be moved inland (Fig. 2), as due to the high rate of the coast erosion, it actually found itself on the beach within 5 years. Further observations were continued at the new monitoring point of the State Organization of the Kaliningrad region "Baltberegozaschita". In 1999, a relatively low coastal dune protecting Kosa settlement from storm waves located on a flat plain was intensely eroded during a storm. [7]

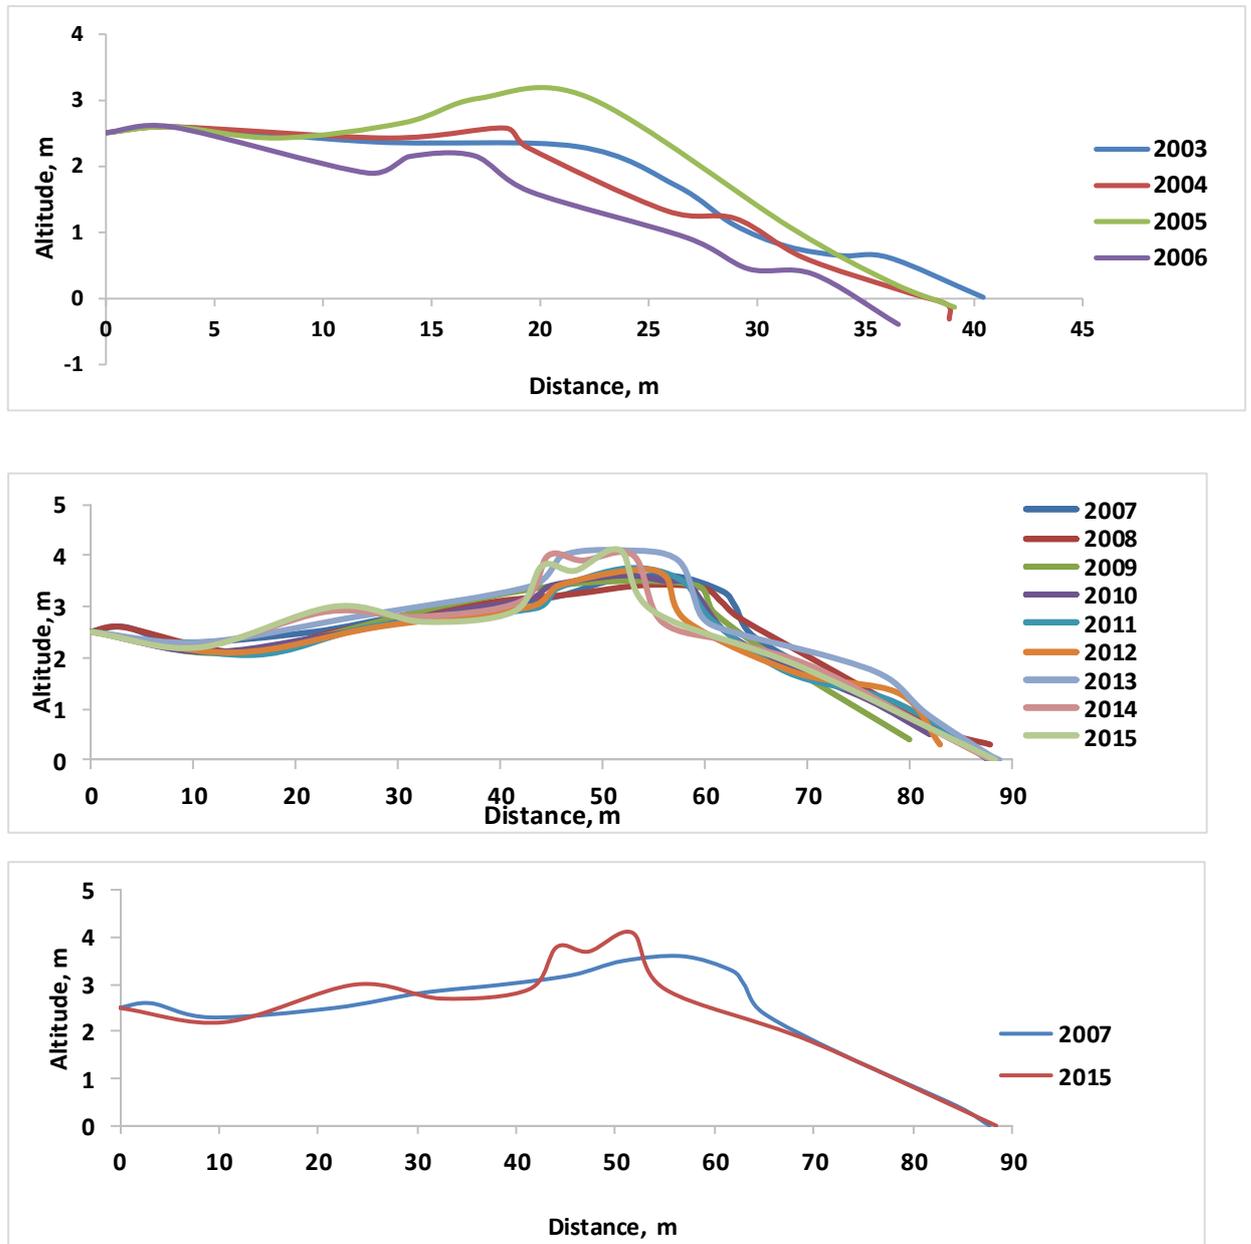
Fig. 3. Seashore dynamics at the village of Kosa: (a) – primary monitoring point, Rp. 10 m, 2003-2006; (b,c) – new monitoring point, Rp. 52, 2007-2015.

Over the following years, the trend of the coastal abrasion continued, as evidenced by monitoring observation data collected by IO RAS. According to the monitoring data collected from 2003 to 2006, the front dune base moved more than 4.5 m. (Fig. 3a)

Between 2007 and 2015, the base of the sea slope of the front dune retreated nearly by 10 m, the average retreat rate also accounted for -1.1 m / per year. (Fig. 3 b,c). The average beach width remained almost unchanged within the range of 20-30 meters.

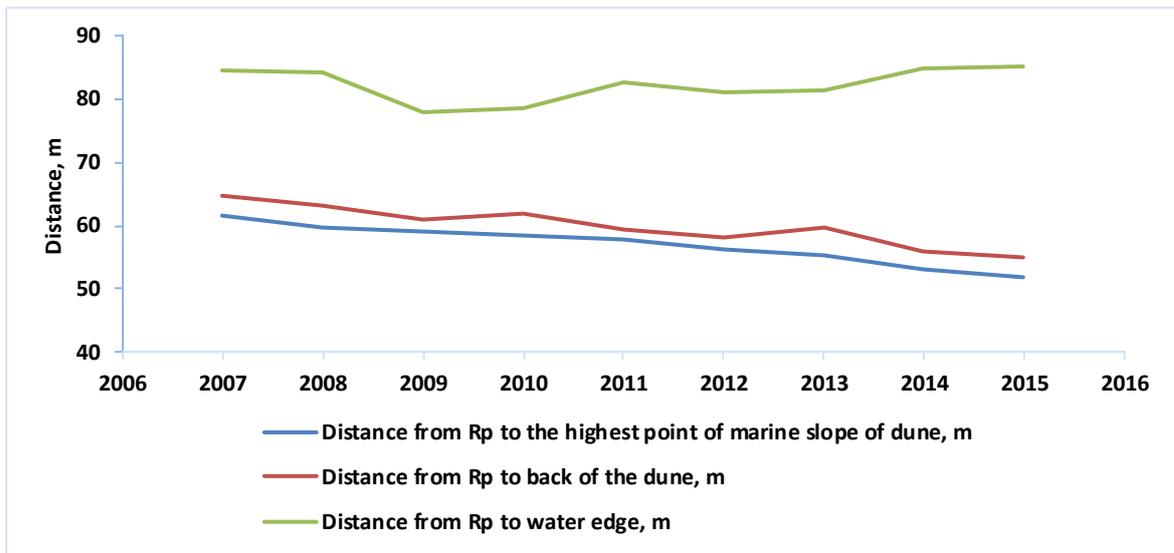
Fig. 4 – Diagram of the change of the seashore position near the village of Kosa between 2007-2015

The diagram (Fig. 4) shows the way the position of the top and bottom of the sea slope of the front dune, as well as the shoreline from the permanent monitoring point changed between 2007 and 2015.

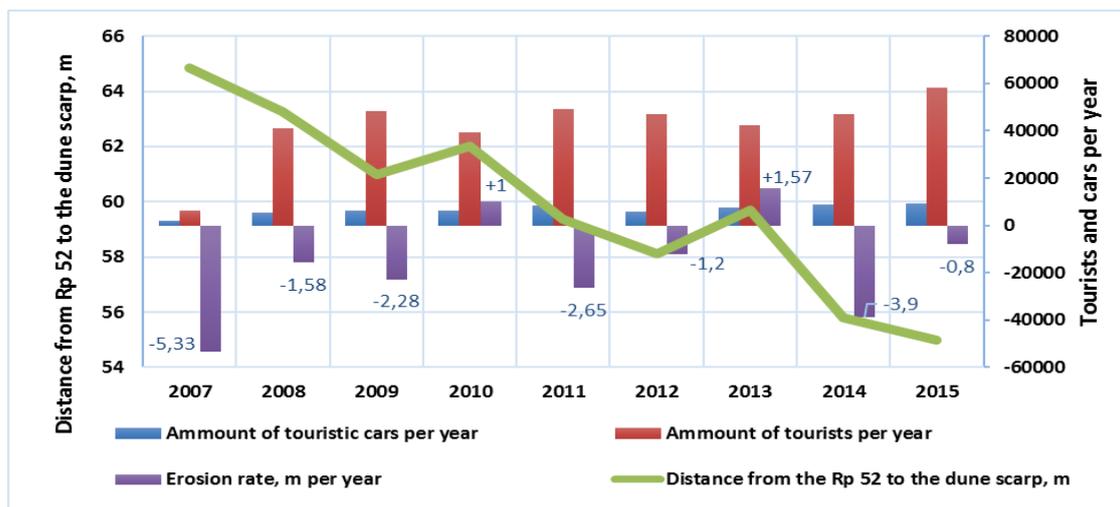
Fig. 5 – Dependence of the coast dynamics on anthropogenic load, 2007-2015

Since 2007, the anthropogenic load on the critical segment has increased due to the launch of the private ferry along the route "Baltijsk – the Vistula Spit" instead of the military ferry running between 1995 and 2007. The private ferry began running through the Baltic Strait 7-8 times a day. Passenger traffic of tourists, according to the "Baltic Shipping Company", which was carrying out the transportation, increased between 2008 and 2015 by 17270 persons / per year, the number of imported vehicles increased by 3818 units / per year. (Fig. 5).

Destruction of the coast continued alongside with increase in the number of tourists visiting the Baltic Spit. However, despite the increase in tourists, the rate of the shore erosion has not increased, which means that the anthropogenic load has almost no effect on erosion of the front dune's sea slope, but it mainly leads to increased deflation and surface degradation of the front dune body located outside of the wave field. The primary reason of the high rate of the front dune erosion is still storm impact and lack of sediment load related to the violation of beach drifting. As a result of degradation of the front dune body due to high anthropogenic load, deflation basins (washout) are formed through which the seawater enters and floods the territory of Kosa village. As a result of high rates of degradation, the volume of the front dune along about 500 m decreased by 25 126 m³ (the front dune in 2015 became 21.3% less than in 2007) between 2007 and 2015. [8].

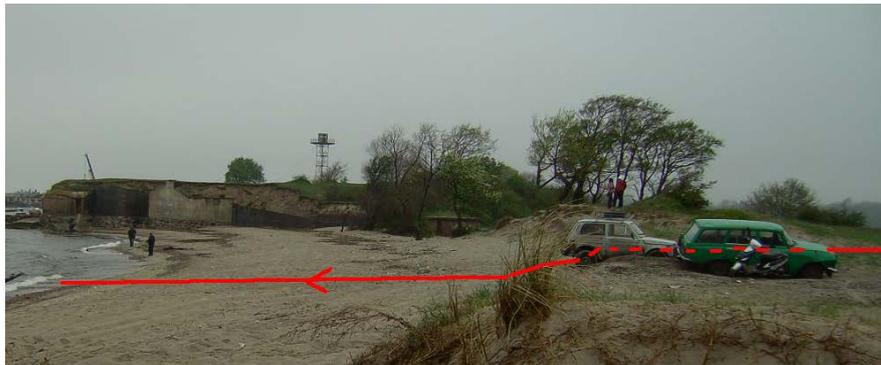
Fig. 6- Cars driving down the degrading front dune

Most of the visitors are concentrated on the northern section of the Baltic Spit near the village; tourists use the deflation basins of the front dune as hills and drive down them to the beach by cars, thus increasing degradation of the front dune. (Fig. 6)

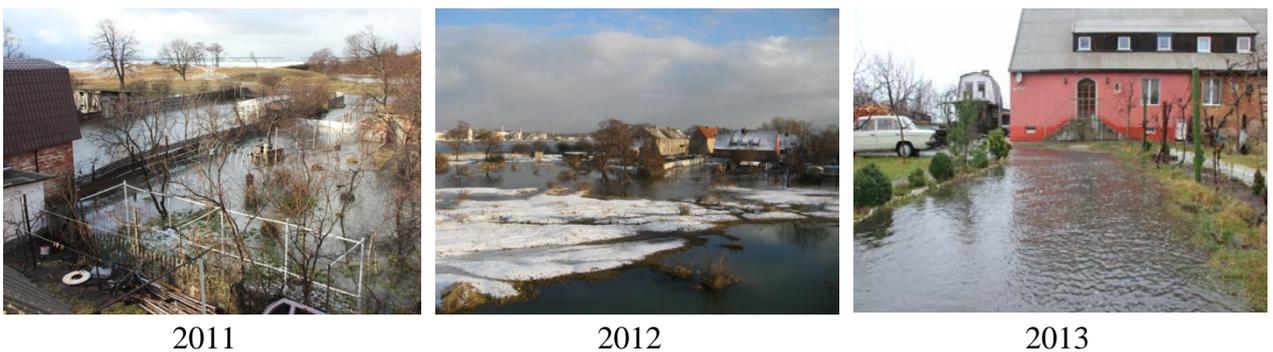
Fig. 7- Photos of the flooded areas of the village of Kosa

Increasing rates of the dune's degradation led to the fact that the village of Kosa found itself in the flooding zone. The village was first flooded in November- December 2011, the next flooding happened in January 2012, and finally the village of Kosa was flooded for the third time in December 2013 during Xavier hurricane (Fig. 7).

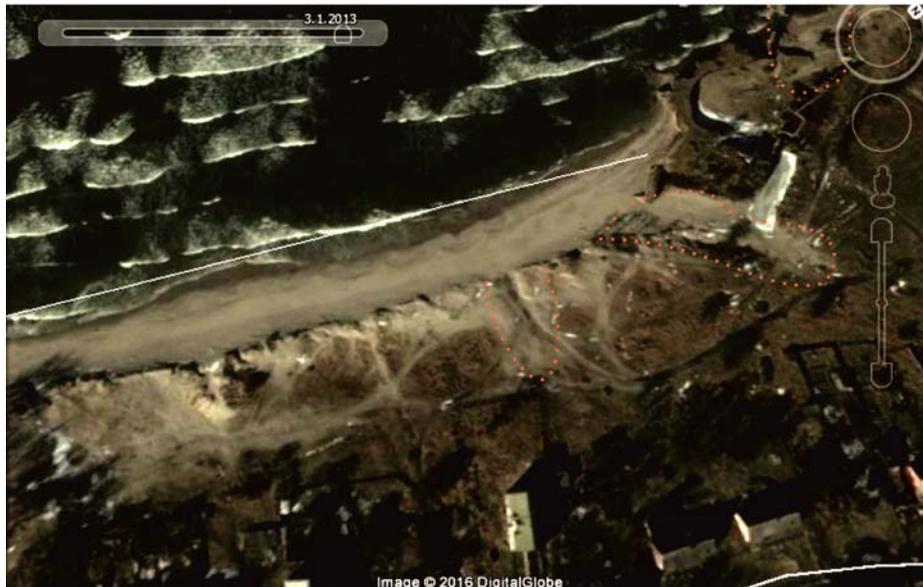
Fig. 8 – Scheme of sea waves' outburst points on the territory of Kosa village

The village of Kosa is located on a flat plain, so there is a threat of flooding of the major part of the village under extreme storm conditions through three main washouts in the front dune body (Fig. 8)
